CHARACTERIZATION OF SURFACES PRIOR TO ADHESIVE BONDING

*NORTHROP CORPORATION
AIRCRAFT DIVISION*

JULY 1976

TECHNICAL REPORT AFML-TR-76-118
FINAL REPORT FOR PERIOD 15 MARCH 1975 - 15 MARCH 1976

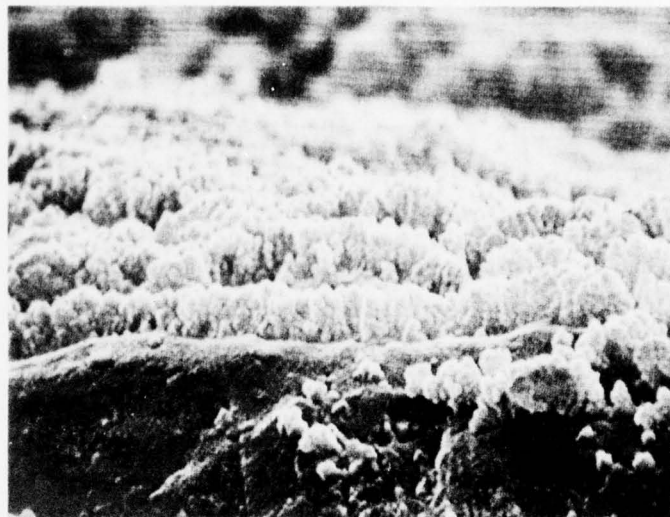
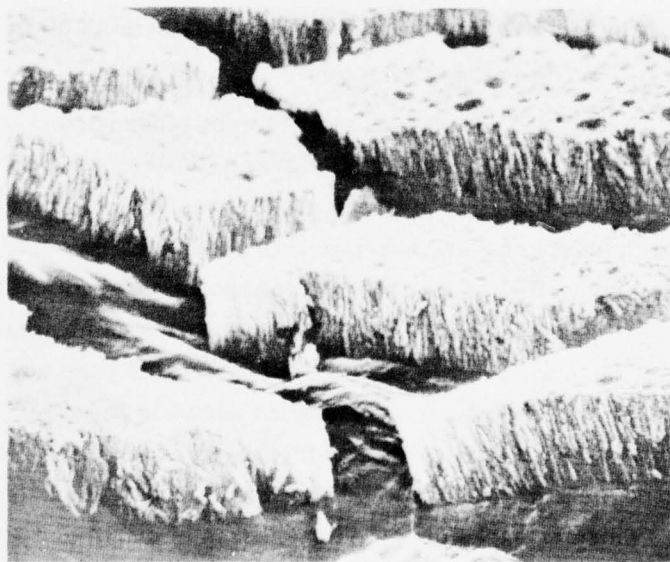
FIGURE 9. OXIDE THICKNESS ON 7075-T6 ANODIZED IN PHOSPHORIC ACID

The SEM photomicrographs in Figure 9 show the anodic coatings as viewed through their cross-section. These photographs reveal information on the film thickness as well as its longitudinal structure. The dispersed nature of the oxide is due to the differences in ductility between the brittle anodic film and the ductile base metal, and their relative displacements during the bending and cracking of the 90° bend specimen. In the foreground of Figure 9a is the crack in the base aluminum.

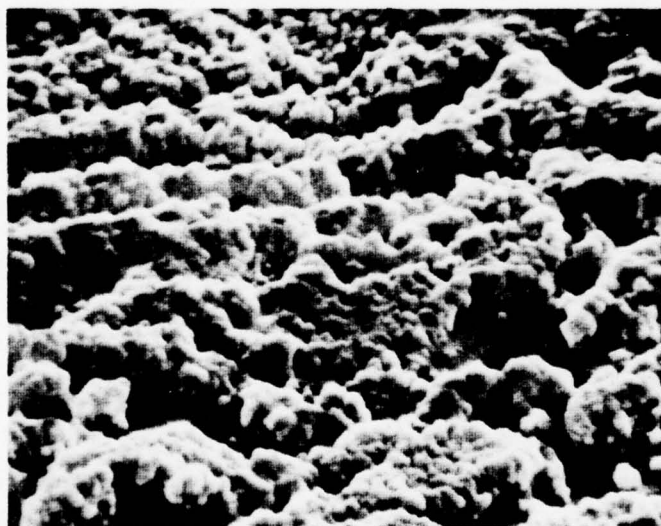
FIGURE 15. OXIDE THICKNESS ON BARE 7475
ANODIZED IN PHOSPHORIC ACID

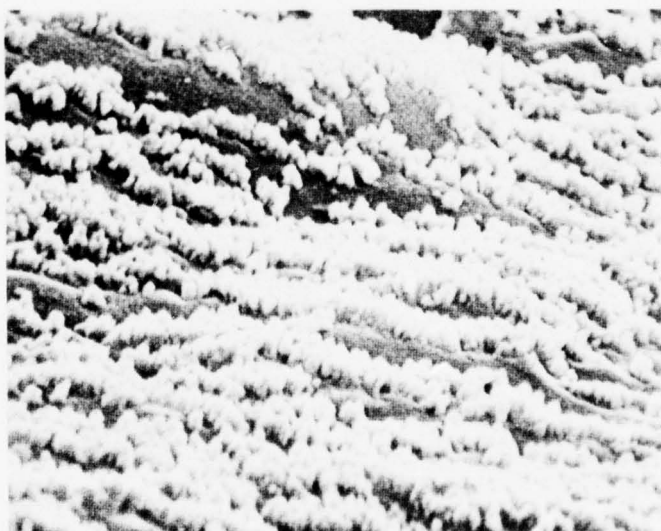
a. NORMAL VIEW SHOWING LACK OF GRAIN BOUNDARY ETCHING

b. PARALLEL VIEW SHOWING OXIDE THICKNESS

FIGURE 22. ANODIZED SURFACE OF BARE 2024-T3 —
PABST PRODUCTION PANEL

The most obvious difference between the anodized surfaces of 2024-T3 and 7075-T6 is the absence of grain boundary attack on the 2024-T3 surface. This etching of the grain boundaries occurs during the deoxidizing step, just prior to anodizing, and may be due to the differences in grain boundary constituents between the two

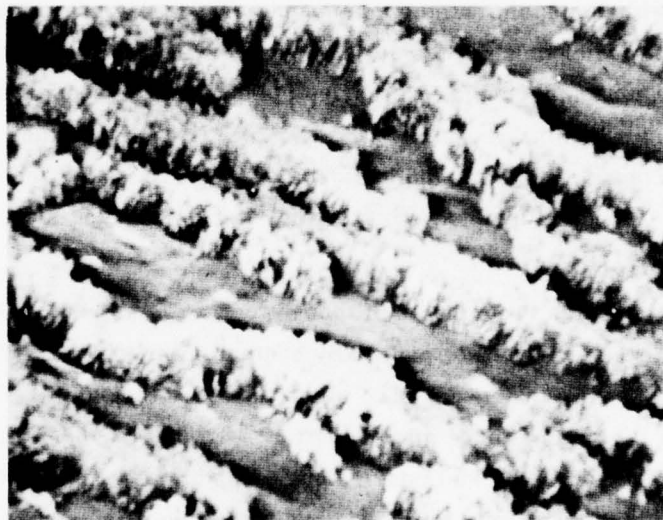
FIGURE 25. OXIDE THICKNESS ON BARE 7075-T6 — ROCKWELL
SPECIMEN ANODIZED IN PHOSPHORIC ACID

as shown in Figure 25, was measured to be about 4000Å. This value also compares favorably to panels anodized elsewhere under similar conditions, with a typical one shown in Figure 20.

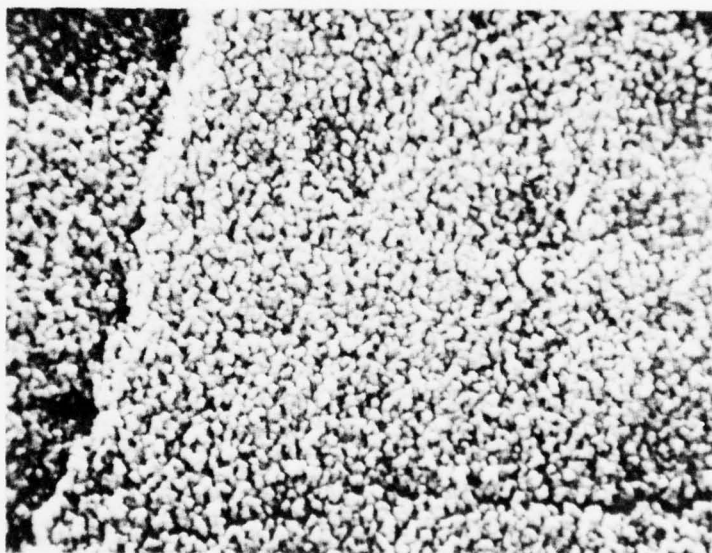
FIGURE 28. EFFECT OF RATE OF VOLTAGE APPLICATION ON THE OXIDE CELL STRUCTURE OF BARE 7075-T6 ANODIZED IN PHOSPHORIC ACID

The rate of initial voltage application during an anodizing run is an important parameter in the anodizing process. In laboratory-type anodizing runs with panels of small surface area, it is possible to apply 10 volts instantaneously to the specimens at the outset of the run. The result is a current surge and subsequent exponential decay to a steady-state value as the oxide layer is grown on the surface. The current surge is due to the low resistivity of the virgin surface. The magnitude of this current spike is often 10 or more times greater than the steady-state value. In a production environment where panel surface areas are on the order of hundreds of square feet (compared to a few square inches on a laboratory panel), it is difficult to accommodate these high current surges at the outset of the anodizing run. Thus, a gradual application of the initial anodizing potential is highly desirable.

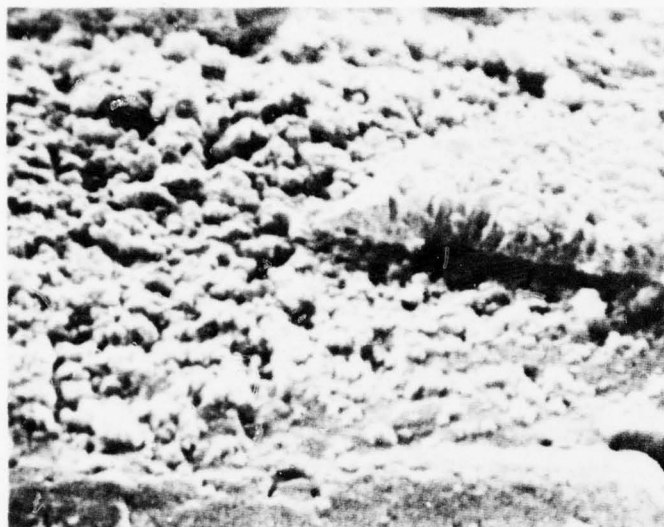
FIGURE 39. EFFECT OF SPECIMEN SPACING ON OXIDE THICKNESS —
BARE 7075-T6 ANODIZED IN PHOSPHORIC ACID

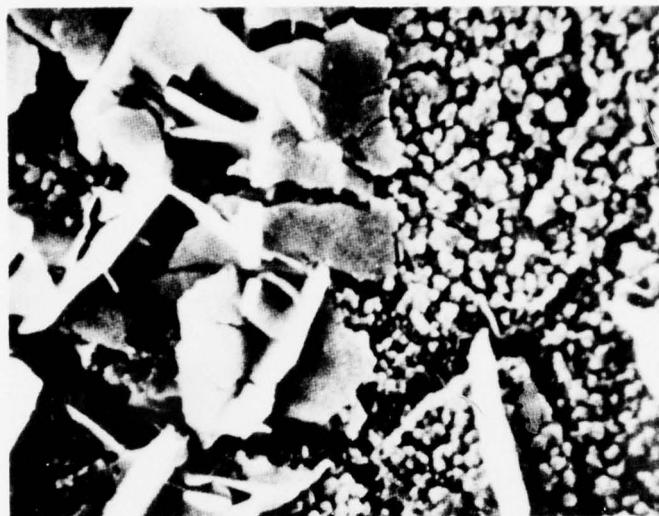
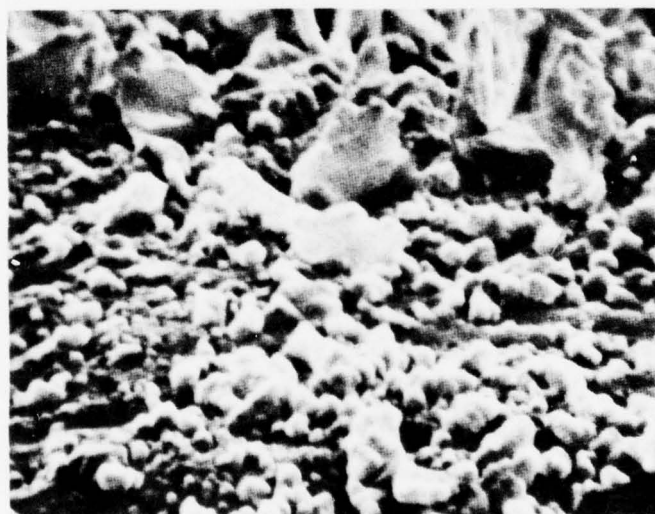
FIGURE 42. SURFACE OF BARE 7075-T6 IMMERSSED IN PHOSPHORIC ACID BATH FOR 20 MINUTES WITH NO VOLTAGE APPLIED

The surface character of the specimen of bare 7075-T6 which was immersed in the phosphoric acid bath for 20 minutes with no anodizing potential is shown in Figure 42. As with the deoxidized panel previously discussed, the character of the surface is quite different from that of the standard anodized surfaces. Note the presence of the film-like particulates on the surface of the specimen at the left of Figure 42a and near the top of Figure 42b. Preliminary analysis indicated that this film was copper depositing out of the anodizing bath. The bath had previously dissolved copper while anodizing other 7075-T6 panels. However, Auger analysis revealed excessive amounts of lead on this surface, indicating that this may be a lead deposit from the lead-lined anodizing tank. Figure 43 shows an Auger trace from the surface shown in Figure 42. The location of the primary lead peak is at 90 electron volts.

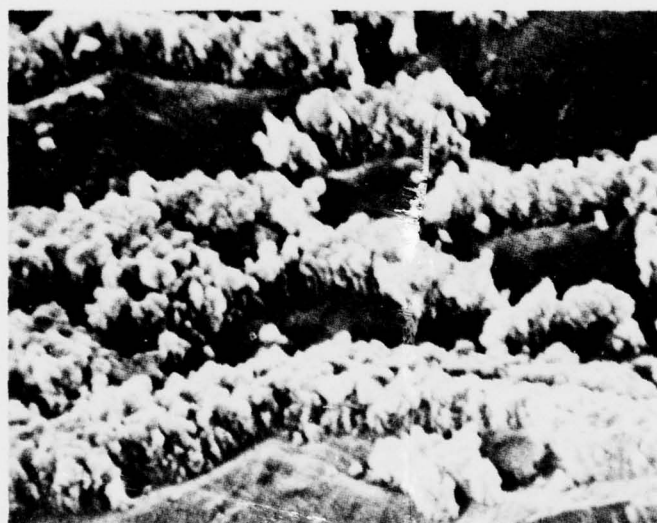
FIGURE 44. SURFACE CHARACTER OF BARE 7075-T6 — ANODIZED IN PHOSPHORIC ACID, THEN LEFT IN BATH 2 MINUTES WITH VOLTAGE OFF

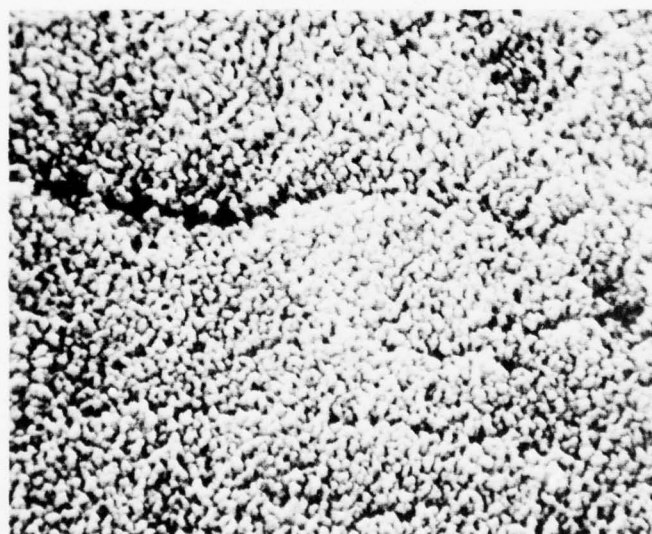
FIGURE A5. CELL STRUCTURE OF STANDARD SURFACE OF BARE
7075-T6 ANODIZED IN PHOSPHORIC ACID

- c. Inspection at a magnification of 14,000X normal to the surface plane must reveal an anodic coating appearance similar to that shown in Figure A5. Verification of the presence of a porous anodic coating, by observation of the structure and porosity of the oxide layer, is critical to the acceptance of the anodized panel. Any surface not exhibiting a uniform, porous oxide structure between the grain boundaries is rejectable. Typical examples of rejectable surfaces are shown in Figure A6. In addition, the size of the oxide cells must be similar to those shown in the standard photomicrograph in Figure A5. The lower

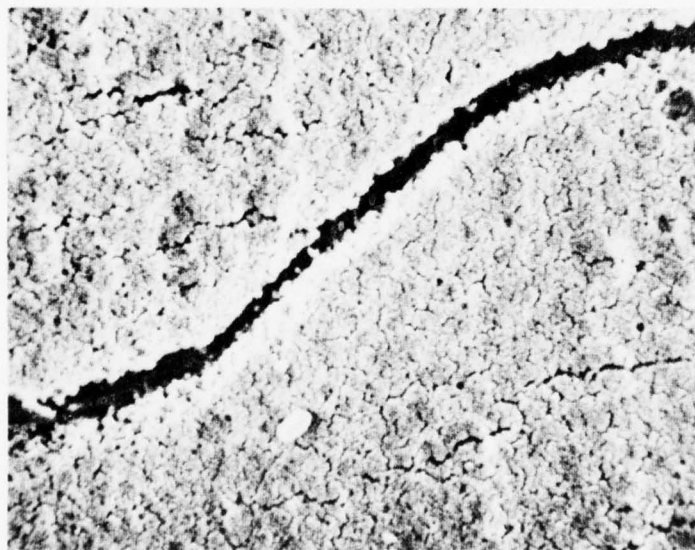
FIGURE A8. SURFACES OF BARE 7075-T6 ANODIZED IN PHOSPHORIC ACID AND REJECTABLE DUE TO INADEQUATE OXIDE CELL STRUCTURE
